Manhole Inspection Summary

Manhole # S43I__050MH

Location Address: **1522 Eastern av**

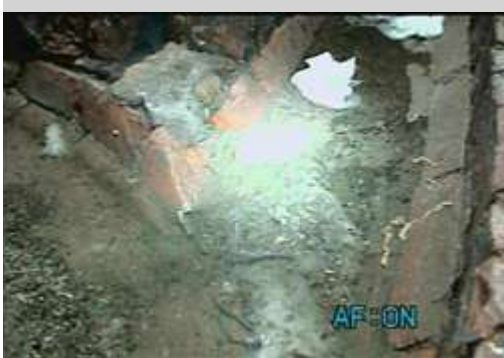
misc

channel debris

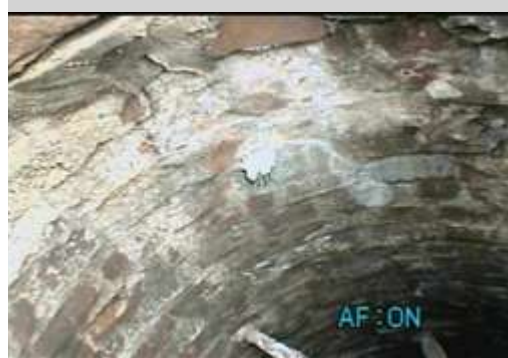
Defect 3

Count: **4** Missing: **1** ☒ **Corroded**

missing step

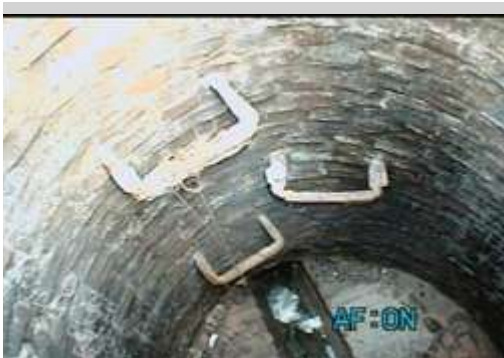
Defect 2

corroded steps

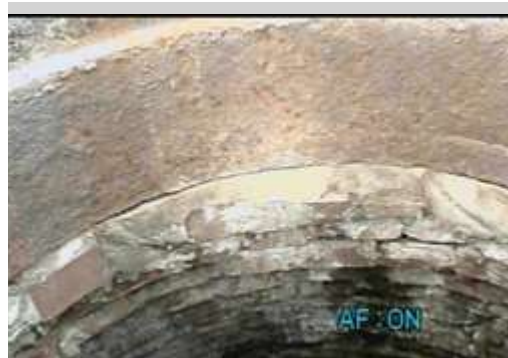
Defect 1

Condition: ☐ Sound ☐ Cracked ☐ Root Intrusion ☒ **Loose Brick** ☐ Deteriorated

Chimney loose bricks,
frame adjustment

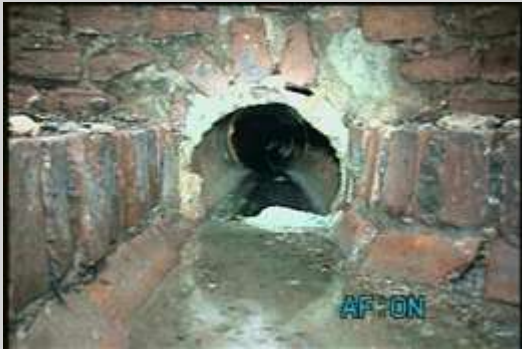
12 O'Clock Outflow

Comments **flow directions on map were not the same as the actual flow patterns. 12 oclock was flowin towards S Caroline St.**
